**Town of Grafton  
Self-Evaluation and Transition Plan  
June 2019**

# **TOWN OF GRAFTON – SELF-EVALUATION AND TRANSITION PLAN**

## VII. ADA TRANSITION PLAN

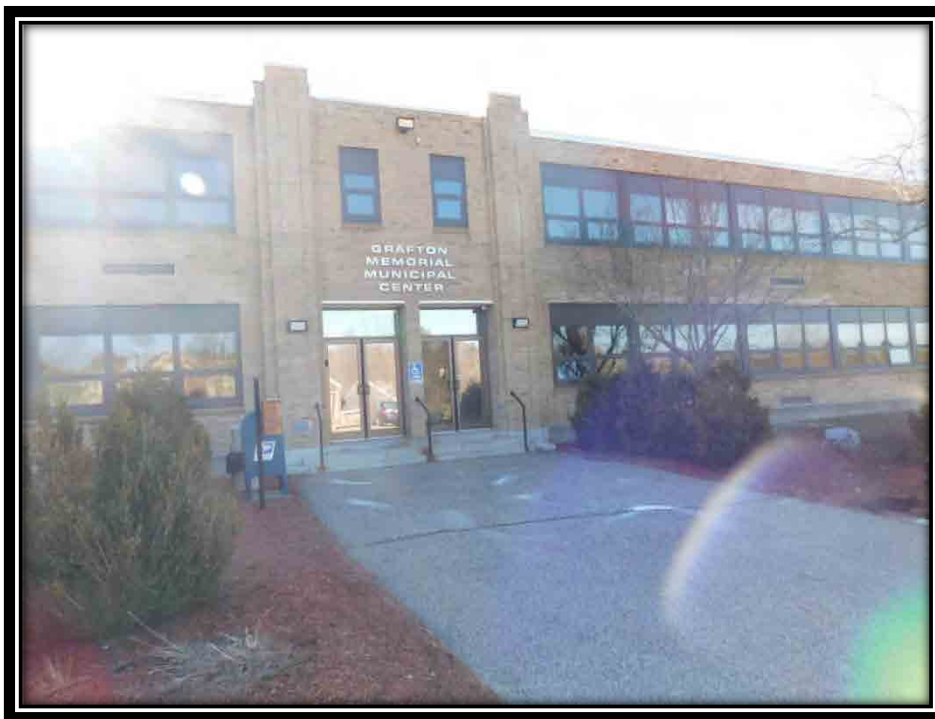
**General Description or Obstacle Which Limits Mobility or Access:** Both “accessible” entrances at the building rear have stairs with railings on one side only. The entrance near the vault lacks van accessible signage. The accessible signage at the northern entrance is too low. The approach to the northern most accessible entrance closest to the elevator has running slopes that vary up to nearly 7.0% which will require railings. In addition, the landing is only 4' x 4' and does not meet the required 5' x 5' for a ramp at the directional change. Most of the exterior and interior doors (when applicable) exceed the maximum operating force (15 lbs. – exterior; 5 lbs. – interior) and do not meet the minimum closing speed of 6 seconds. Interior stair railings are too wide, are not oval or round, and extensions are not provided at the top and bottom of the stairs. Nearly all interior doors lack tactile signage and have non-compliant knob-style hardware. The hallway drinking fountains are not “high-low”. There are a number of protruding objects in the hallways (dispensers, TV monitors, fire extinguishers) which exceed that allowed. Most glass panels on doors/entries exceed the maximum height under the ADAAG. Some light switches and controls exceed the maximum height for a compliant reach range, inclusive of allowed industry tolerances. Some of the office areas do not have compliant clear widths for maneuverability due to placement of desks, cabinets or other items. The designated “accessible” Level 1 and Level 2 bathrooms do not fully adhere to various setback, placement and height requirements and have other areas of non-compliance. The school department employee lounge has a number of items (phone, towel dispenser, controls) that exceed the maximum reach range. In addition, the guard for sink plumbing is not in place. Two vaults in the Town Clerk's Office have reduced maneuverability, changes

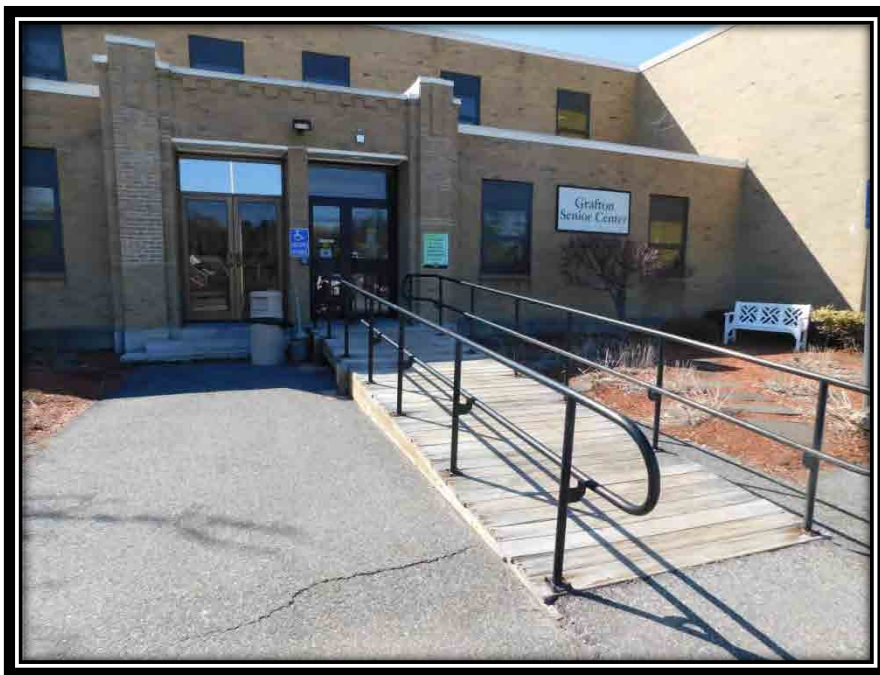
**General Description or Obstacle Which Limits Mobility or Access:** The accessible signage for the rear parking is too high at the top of the signs. None of the accessible spaces in the front or back are designated as van accessible. The front and back ramps have various elements of non-compliance including running slope, abrupt changes in level surface, and deterioration. Interior hallway doors exceed the maximum operating force (5 lbs) and do not meet the minimum closing speed of 6 seconds. Nearly all interior doors lack tactile signage and have non-compliant knob-style hardware. The hallway drinking fountain is not “high-low”. Most glass panels on doors/entries exceed the maximum height under the ADAAG. Some light switches and controls exceed the maximum height for a compliant reach range, inclusive of allowed industry tolerances. Some of the office areas do not have compliant clear widths for maneuverability due to doorway width, placement of desks, cabinets or other items. The designated “accessible” Level 1 and Level 2 bathrooms do not fully adhere to certain height and placement requirements as well as some other areas of non-compliance. The stage in the gymnasium has no vertical access. Stairs on each side of the stage have non-compliant railings as they are provided on one side only and do not extend the slope distance of one tread then 12” parallel to the floor. The stage is closed to the public and is used only for storage. Unless the use of the stage changes, no other action is required at the present time except for the placement of a formal barrier (chain, rope, etc.) with signage restricting access to the stage.

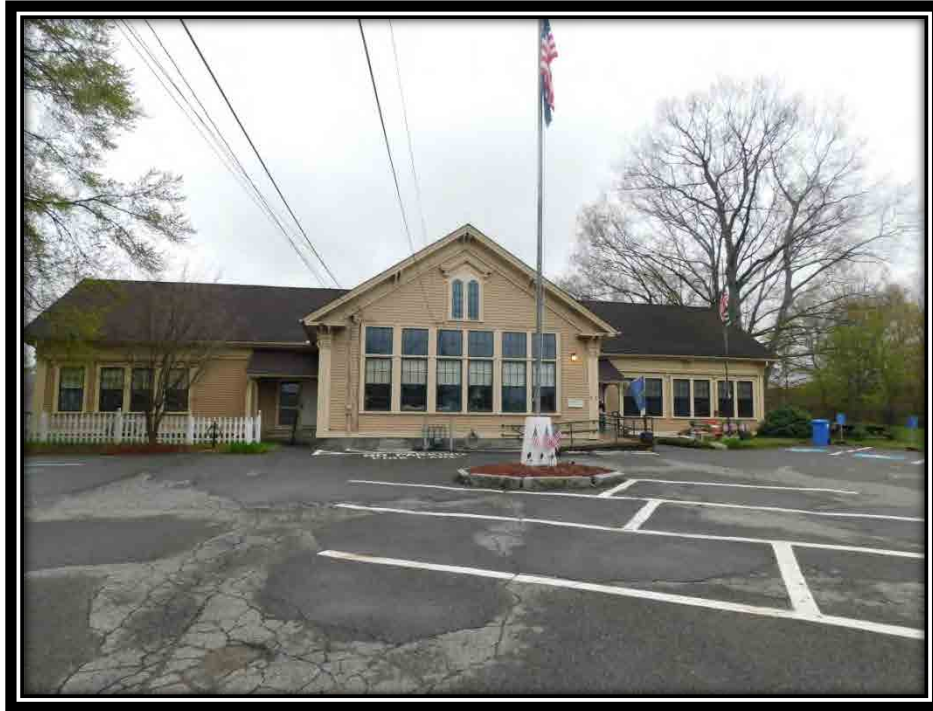
**General Description or Obstacle Which Limits Mobility or Access:** There are two separate accessible parking areas, each consisting of two spaces. The designated accessible spaces to the left of the building and closest to the ramp lack signage and do not have an access aisle. The accessible spaces to the right of the building have non-compliant signage, lack an access aisle, and have a non-compliant level surface including running and cross- slopes. Neither area has a van-accessible designated space. There are abrupt changes in level surface at the base of the ramp to the main entrance, along segments of the ramp, and at the entrance threshold. The ramp railings are not consistently within the required lower and upper railing height range. Stair railings (front and back) are non-compliant. A set of stairs at the back of the building also has non-compliant open risers. The front entrance door and egress door do not meet closing speed requirements. Interior doors lack tactile accessible designation signage and have non-compliant knob hardware. The drinking fountain is not “high-low”. Both the men’s and women’s bathrooms do not fully adhere to certain height and setback requirements as well as other areas of non-compliance.

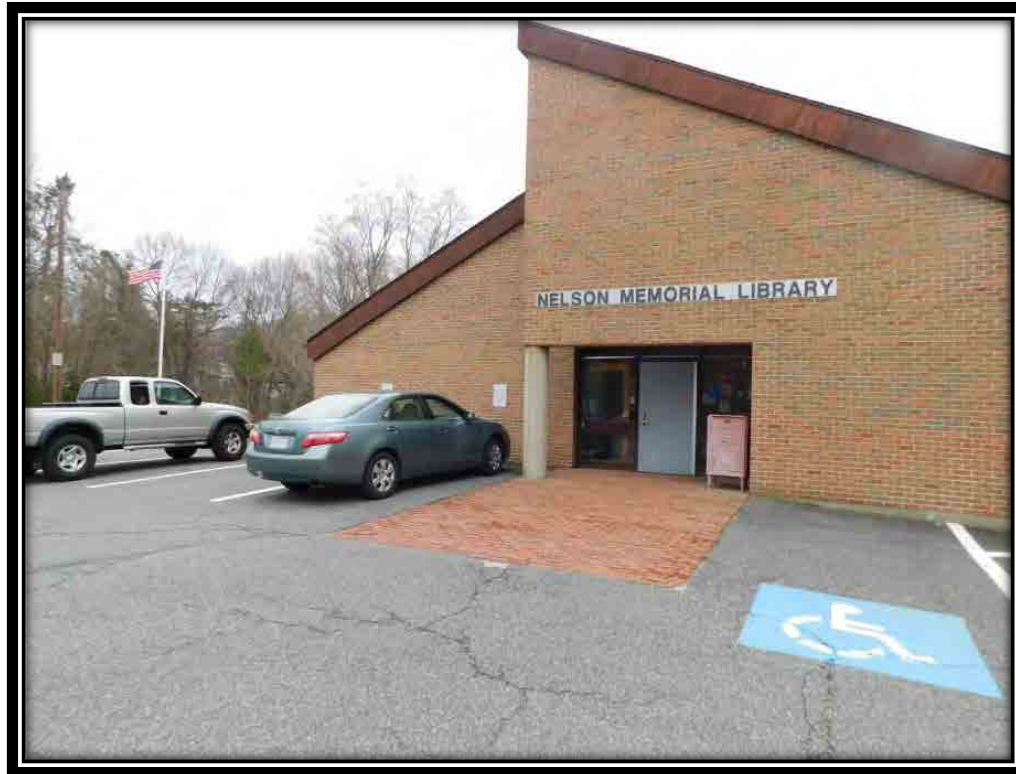
**General Description or Obstacle Which Limits Mobility or Access:** The “accessible” parking spaces do not meet signage and slope requirements and lacks a van accessible accessible space. The brick walkway to the entrance has numerous abrupt changes in level surface due to deferred maintenance. The interior doors exceed the maximum operating force (5 lbs.) and both interior and exterior doors do not meet the minimum closing speed of 6 seconds. Interior doors have non-complaint hardware and lack tactile accessible signage. Light switches and controls exceed the maximum reach range. The drinking fountain is not high-low. An office sink and counter is non-compliant. Both the men’s and women’s bathrooms have numerous items of non-compliance. The women’s bathroom has limited maneuverability. There is no vertical access to the second level. The stair railings to the second level are non-compliant due to shape, size, and lack of extensions. The placement of some tables, chairs, and display holders reduces the minimum required clear width to less than the required 36”. The hardware to the card catalogue is non-compliant.

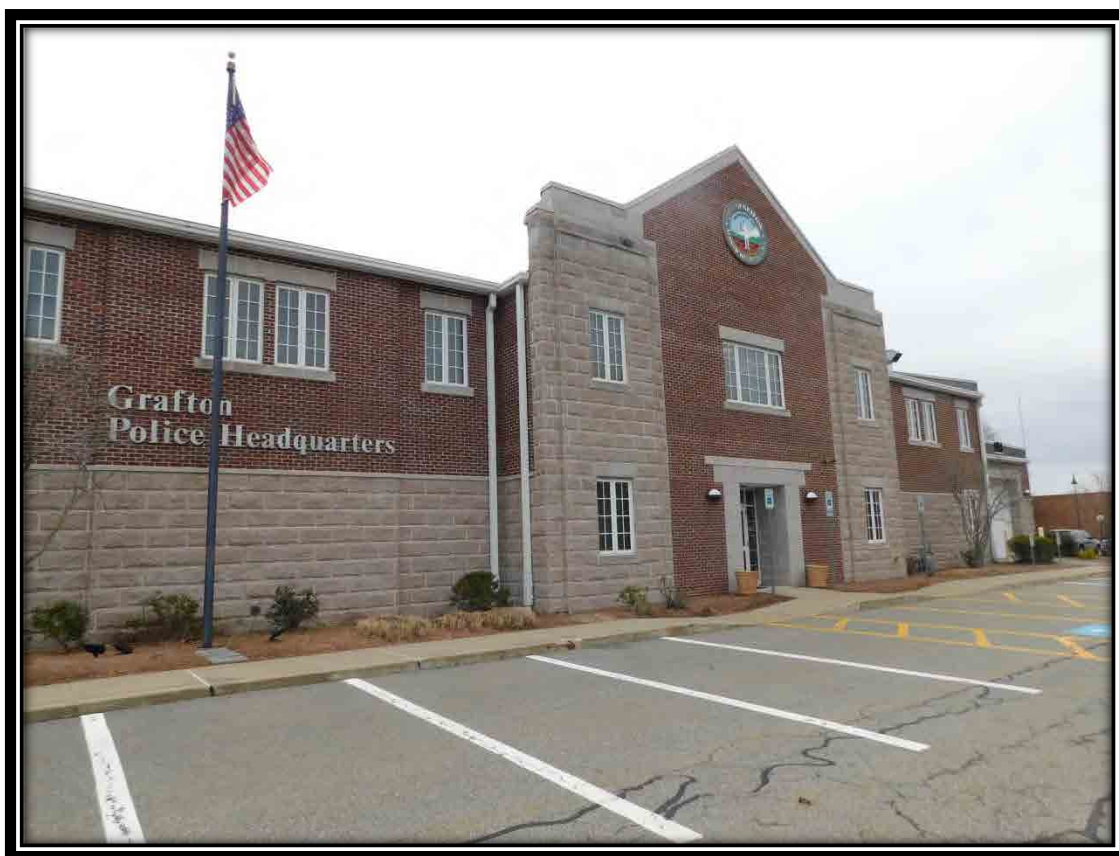
**General Description or Obstacle Which Limits Mobility or Access:** The Police Station is substantially compliant but does have some areas of non-compliance. The signage for the designated accessible parking is 2" to 4" too high. The accessible route(s) from the parking spaces to the front entrance exceed the maximum allowed running slope for a walkway (5.0%) on one side and lacks railings whereas the opposite approach exceeds the maximum running slope for a ramp (8.3%) and similarly lacks railings. The immediate approach at the entry door has a running slope that varies up to 9.6%. Doors exceed maximum operating force and minimum closing speeds. Some interior doors lack tactile signage or the signage is not mounted on the latch side. Various controls, switches, and telephones exceed the maximum reach range. The drinking fountain (basement level) is not "high-low". The kitchenettes (2 on 1<sup>st</sup> level, 1 on 2<sup>nd</sup> level) have counters/sinks that are too high and lack knee clearance. The Level 1 Break Room stove has non-compliant controls. The "public" Level 1 Lobby and Level 2 bathrooms have non-compliant toilet paper dispensers due to location. The Dispatch and Level 1 Men and Women's Staff bathrooms have a number of areas of non-compliance. The Level 1 Men and Women's Staff bathrooms

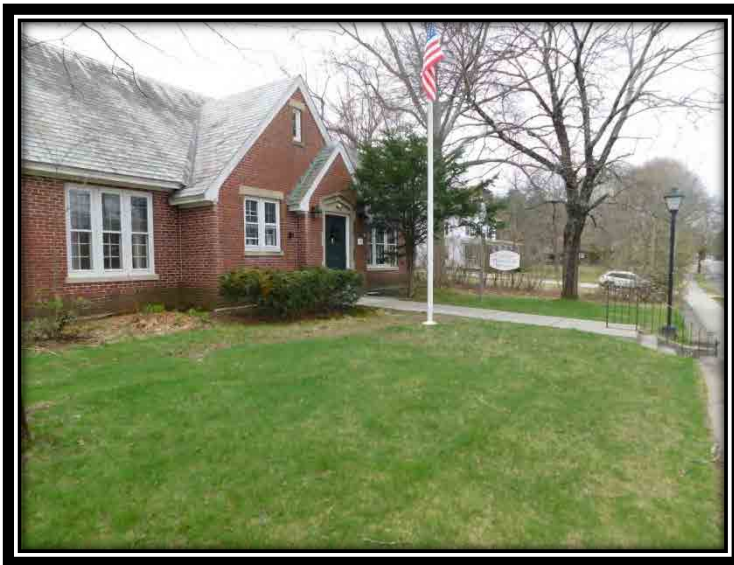
**General Description or Obstacle Which Limits Mobility or Access:** As noted the building has undergone few changes in recent years and as a whole remains non-accessible. A number of modifications are required to achieve compliance under both the 2010 ADA Standards and 521 CMR. There is no designated accessible parking nor is there an accessible entry into the building. The existing entrances (front and rear) have stairs with non-compliant railings. Once inside the building, both the front and rear entrances have a small vestibule with an interior door which opens into the accessible route thereby restricting maneuverability and adequate clear width. Exterior and interior doors have non-complaint hardware. Interior doors lack tactile accessible signage. The bathroom is not accessible and is of inadequate size to achieve minimum required clearances. There is insufficient clear width to the office. The meeting/work table does not provide adequate knee clearance and a cross support for the legs eliminates wheelchair usage. The placement of some furniture and display items reduces the minimum required clear width to less than the required 36".

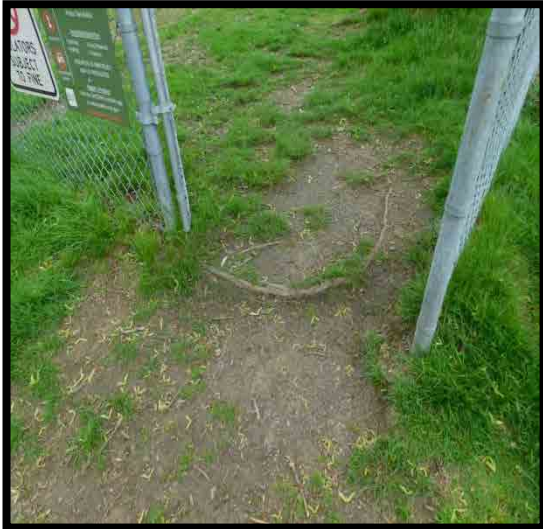
Photo Perry Hill 1

**General Description or Obstacle Which Limits Mobility or Access:** There is no accessible route to and within the playground area. There is an abrupt change in level surface at the main gated entrance with the interior consisting of non-compliant wood chips. None of play components nor the picnic table are accessible. There is no accessible route to the “basketball court/hoop”. Due to the deteriorated nature of the court and basketball hoop, coupled with the cost to achieve accessibility compliance, the use of this area should be discontinued.
